**Federal Aviation
Administration**

DOT/FAA/AM-06/10
Office of Aerospace Medicine
Washington, DC 20591

Vaporized Hydrogen Peroxide (VHP®) Decontamination of a Section of a Boeing 747 Cabin

Final Report

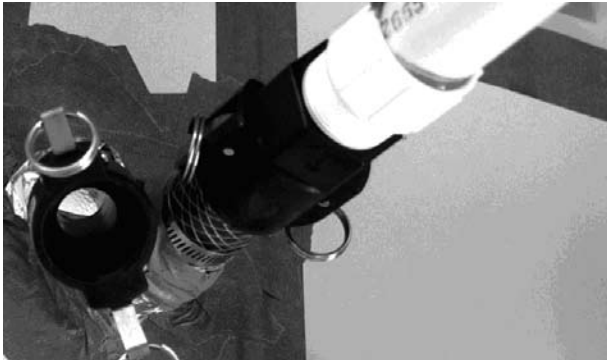
Photograph 1.

Figure 3. Photograph 1 showing the bulkhead penetration of the VHP Inlet pipe and VHP Return (open connector) into the test section of the AERF. Photograph 2 showing the STERIS model 1000 VHP.

Note: Pre-test equipment evaluations determined that the 1¼" piping installed for the VHP inlet generated a high airflow velocity relative to the cabin flow and would disrupt the cabin air circulation patterns for CFD model support work. To reduce the VHP inlet flow velocity, a 3" diameter inlet pipe was installed on the one VHP

1000 generator inlet pipe that would be used for the CFD work. With the expected flow velocity reduction, the new inlet installation was insulated to ensure that VHP condensation did not occur as the flow was slowed in the pipe. Subsequent testing confirmed the calculated velocity reduction. Upon completion to these first (CFD) tests, the VHP inlet from the generator was returned to its original configuration for use in the BI/CI tests.
